the play inspection company

Annual Inspection

Tacolneston Parish Council

Tacolneston Play Area, Tacolneston, Norwich,

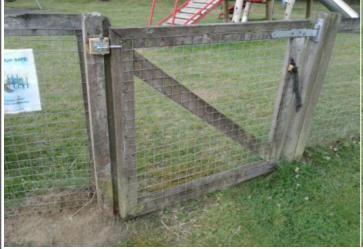
Item:Ancillary Items - GateRisk Level:L - Low RiskManufacturer:Not IdentifiedSurface:Grass

Finding: A number of fixing(s) have worked loose

Action: Secure all loose fixings

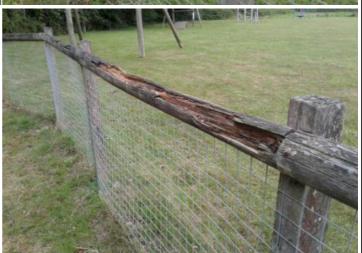
Finding: There are areas or parts of the timber on the structure that have rotted

Action: Replace all affected timbers

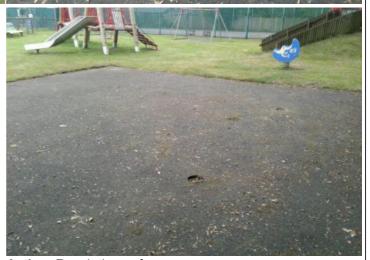
Finding: The redundant safety surface has been damaged **Action:** Repair the surface leaving trip hazards

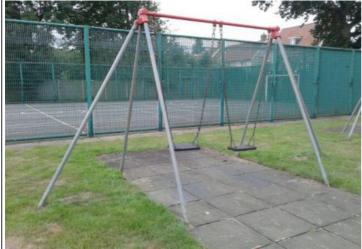
Item:Swings - 1 Bay 2 Seat (Flat)Risk Level:L - Low RiskManufacturer:Wicksteed PlaygroundsSurface:Rubber Tiles

Finding: The chain links are worn in excess of 40% and require renewing

Action: Replace worn chains

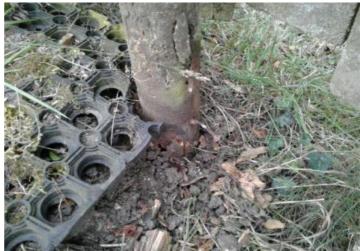
Finding: There are areas or parts of the timber on the structure that have rotted

Action: Replace all affected timbers

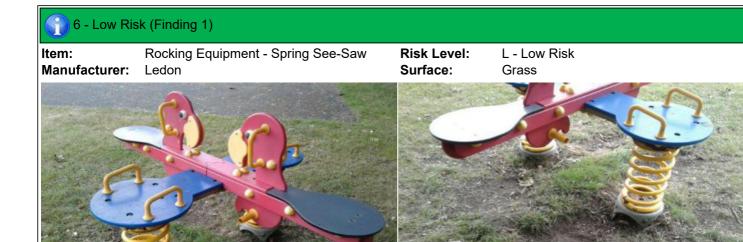
Finding: The surface has eroded in some areas

Action: Reinstate the surface

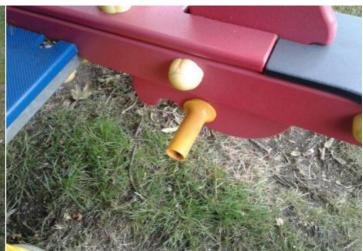
Rocking Equipment - Spring See-Saw Risk Level: L - Low Risk Item: Manufacturer: Surface: Ledon Grass

Finding: The end of handgrips and/or footrests have a cross Action: Monitor - No remedial work recommended section of less than 15cm2 and fail to meet the requirements of BS EN 1176 Part 6

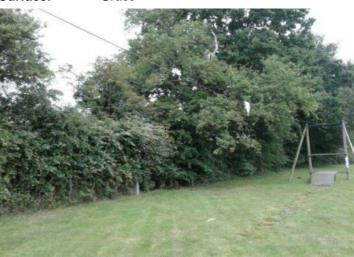
Finding: We have completed a visual inspection of the cable and fixing points from ground level, however it is not possible to fully inspect the cable and fixings without either hiring equipment to gain access or removing the cable and inspecting at ground level. We recommend that the main cable and fixing security is thoroughly inspected at least in accordance with the manufacturers recommendations to check for damage, security or internal rusting, this will help to ensure the continued safe use of the equipment

Action: Inspect in accordance with the manufacturers recommendations

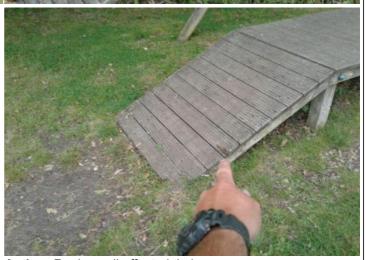
Finding: There are areas or parts of the timber on the structure that have rotted

Action: Replace all affected timbers

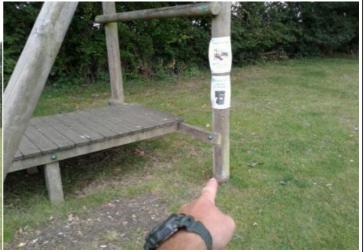
Finding: The timber on this item has severe rot

Action: Remove and replace all affected timber sections

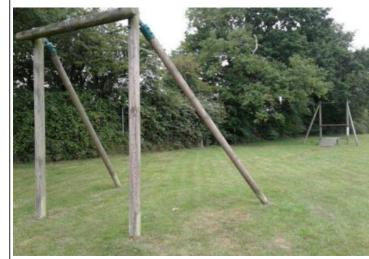
Other - Cable Runway Item:

Finding: The timber supports on this item has severe rot

Action: Remove and replace all affected timber sections

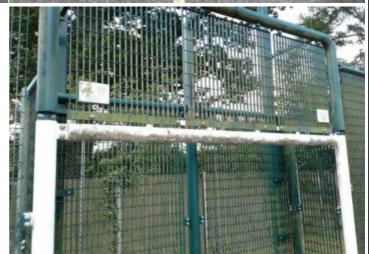
Finding: There is algae or moss on the surface of the equipment

Action: Clean and treat appropriately

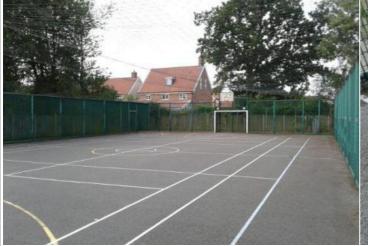
Item: Multi Use Games Area - Multi Use Games Area (MUGA) Risk Level: L - Low Risk

Finding: The concrete surface within the goal mouth is damaged

Action: Monitor use and repair if required

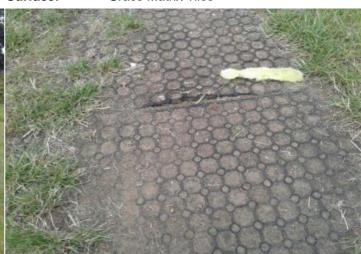
Finding: There are gaps opening between the grass mat tiles

Action: Reinstate surface

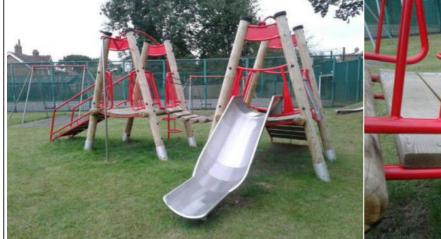
Item:Activity Equipment - Multi Play (Junior)Risk Level:V - Very Low RiskManufacturer:Sutcliffe Play LimitedSurface:Grass Matrix Tiles

Finding: There is/are finger entrapment/s in the platform and the item fails to meet the requirements of BS EN 1176 Part 1 4.2.7.6 Entrapment of fingers

Action: Monitor - No remedial work recommended

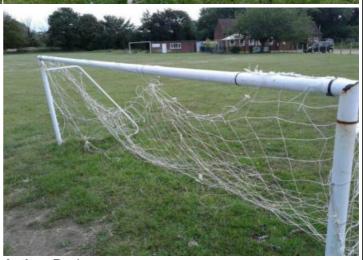
Finding: The nets are damaged

Action: Replace
